BITUMINOUS SURFACING - STRIPPED SEALS

This Technical Note provides guidance to identification of potential causes and corrective treatments for aggregate loss (commonly referred to as stripping) in sprayed seals.

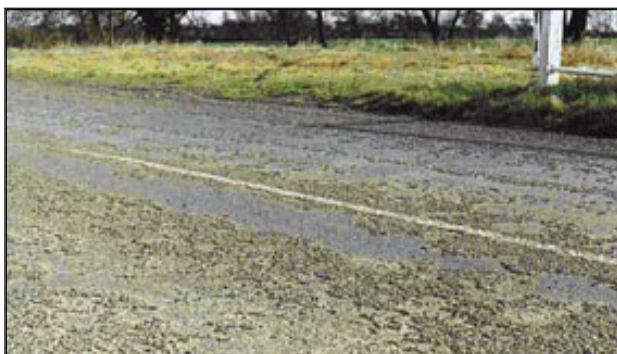
Figure 1: Loss of Aggregate

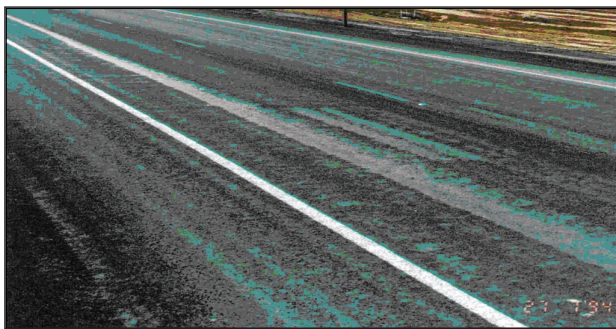
Figure 2: Stripping in new work
